NORWICH RESERVOIR NO. 2 DAM

CHENANGO COUNTY, NEW YORK INVENTORY No. NY 349

PHASE I INSPECTION REPORT NATIONAL DAM SAFETY PROGRAM

NEW YORK DISTRICT, CORPS OF ENGINEERS MAY 1981

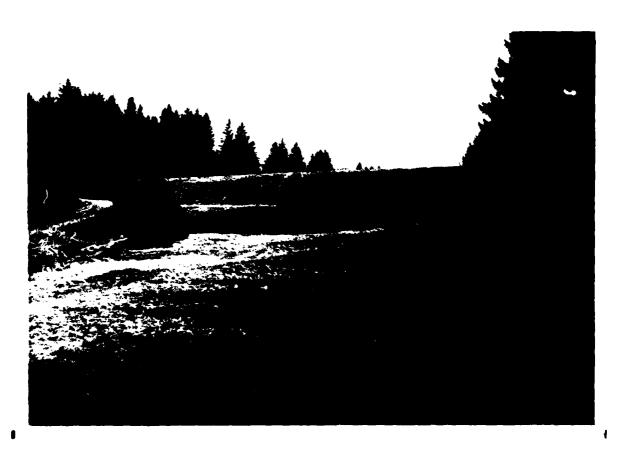
PHOTO #1: Overview of Norwich Reservoir No. 2 Dam Inventory No. NY 349

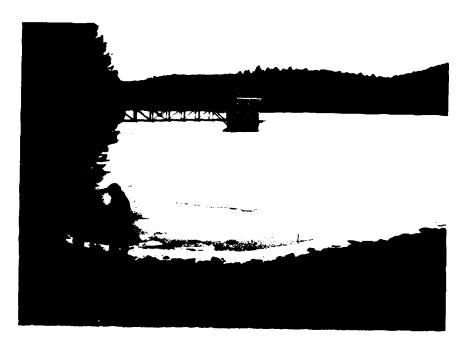
PHOTO #2: Overview of impoundment

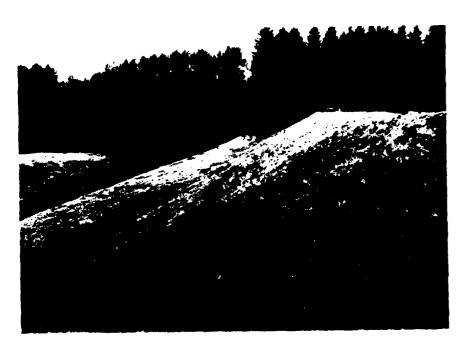
The earthfill embankment of the dam is generally in good condition (See Photos No. 4, 5, 6 and 7). The dam crest is also in good condition except for vehicle ruts and shallow depressions and is presently used for access to Norwich Water Works Dam No. 1 (See Photo No. 3). There was no visible evidence of lateral movement, seepage, major settlement or erosion, or other serious defects.

- 1. Several minor surface sloughs were observed on the right side of the upper downstream slope.
- 2. Several large animal burrows were noted on the upper portion of the downstream slope. Several small animal burrows were observed near the crest on both the upstream and downstream slopes (See Photo No. 18).
- 3. Moderate to large-sized spruce trees are growing on the downstream slope along the left and right abutments; this tree cover overlaps onto the downstream embankment slope on the left side (See Photos No. 5 and 7).

PHOTO #5: Overview of downstream face of dam

- a. Remove all spruce trees that are growing between the crest and lower berm on the left side of the downstream embankment slope, and also any whose trunks or roots may be encroaching onto the right side of the embankment. Trees growing on the abutments may remain. The trees to be removed constitute a potential hazard if uprooted during a storm. This may lead to a loss of freeboard, to a dangerous reduction of embankment width, or to the formation of piping channels if uprooted and the remaining roots rot in place.

- b. The trunks of all cut trees are to be removed and back-filled. Equipment and procedures for this maintenance operation should be such as to avoid damage to existing grass and weed cover on the slopes. Any slopes that become scarred by runoff or traffic should be reseeded and mulched.

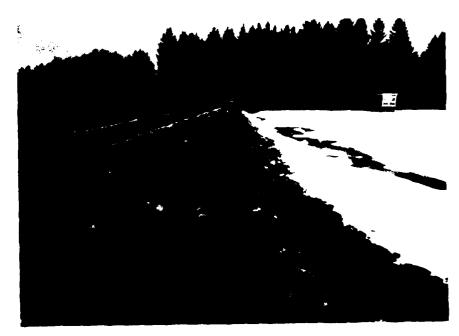
PHOTO #6: Upstream face of dam

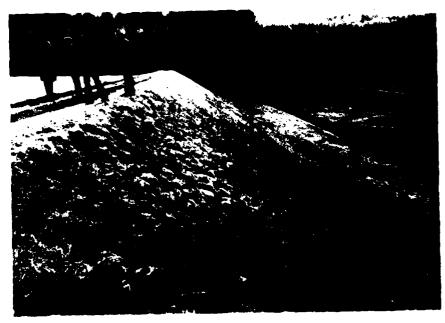
PHOTO #7: Downstream face of dam

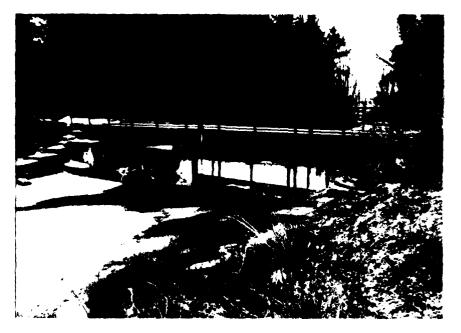
PHOTO #8: View of principal spillway from upstream

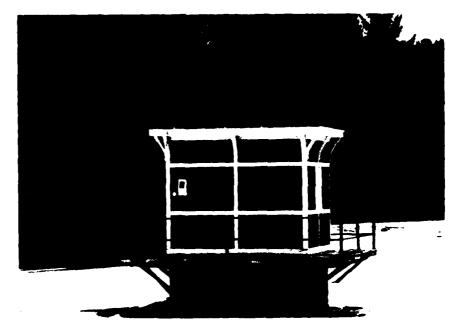
A wood and stone masonry intake structure is located approximately 100 feet from the dam crest within the reservoir (See Photo No. 14). It is connected to the shoreline by a 58 foot long by 5 foot wide access footbridge. Both structures are in good condition showing little sign of deterioration.

PHOTO #14: Intake structure

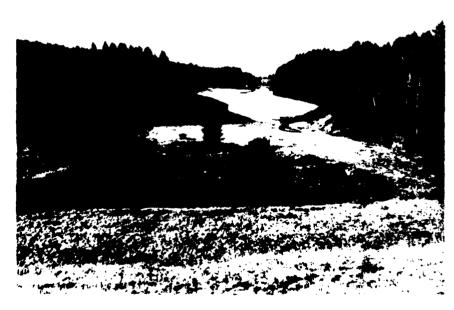
PHOTO #19: Downstream channel conditions - impoundment for Norwich Water Works Dam No. 1 (Inventory No. NY 347)
